# Geomorphic and vegetation changes in a meandering dryland river regulated by a large dam, Sauce Grande River, Argentina

Ana Casado, Jean-Luc Peiry, Alicia M. Campo

Ana Casado, Jean-Luc Peiry, Alicia M. Campo. Geomorphic and vegetation changes in a meandering dryland river regulated by a large dam, Sauce Grande River, Argentina. *Geomorphology*, 2016, 10.1016/j.geomorph.2016.05.036 . hal-01332432

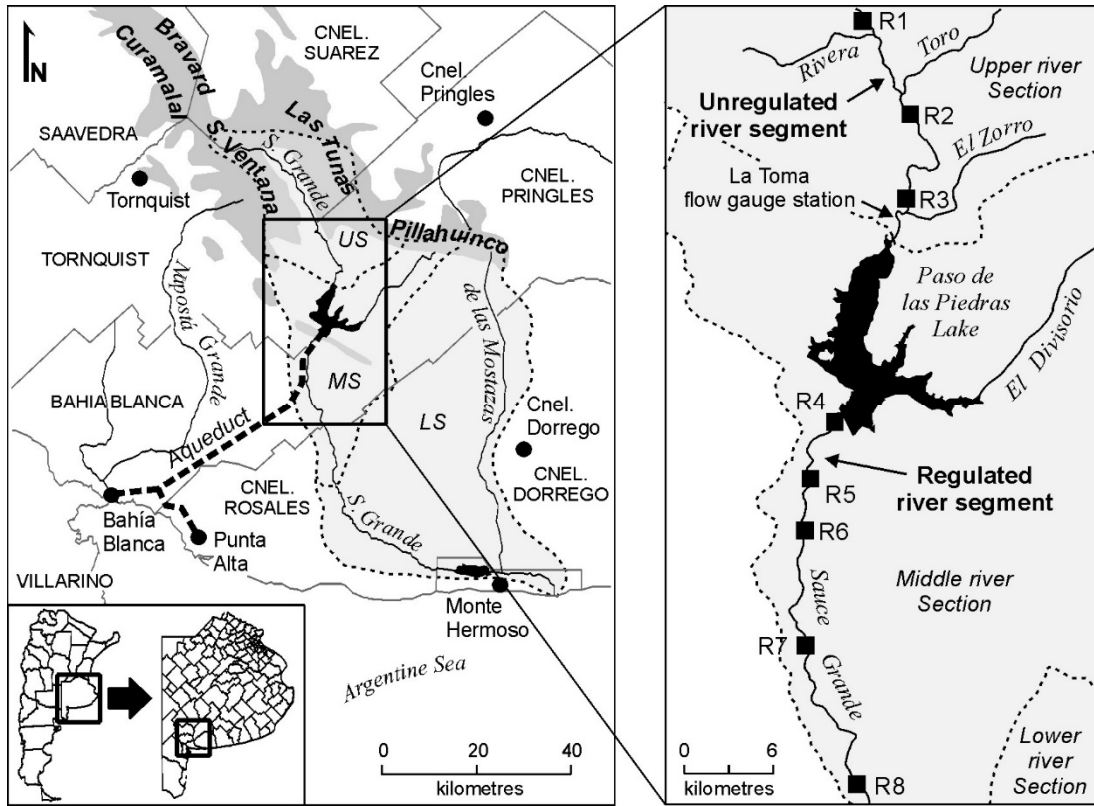
Fig. 1. Map of the Sauce Grande River basin showing main regional features (left) and the river segments selected for analysis (right). The location of reference river reaches (R) along each river segment is also illustrated. US, MS and LS in the left map designate the upper, middle, and lower river sections, respectively.

present channel conditions (2011-2012) were performed for eight reference reaches of 1-km length located above (3 reaches) and below (5 reaches) the dam (Fig. 1).

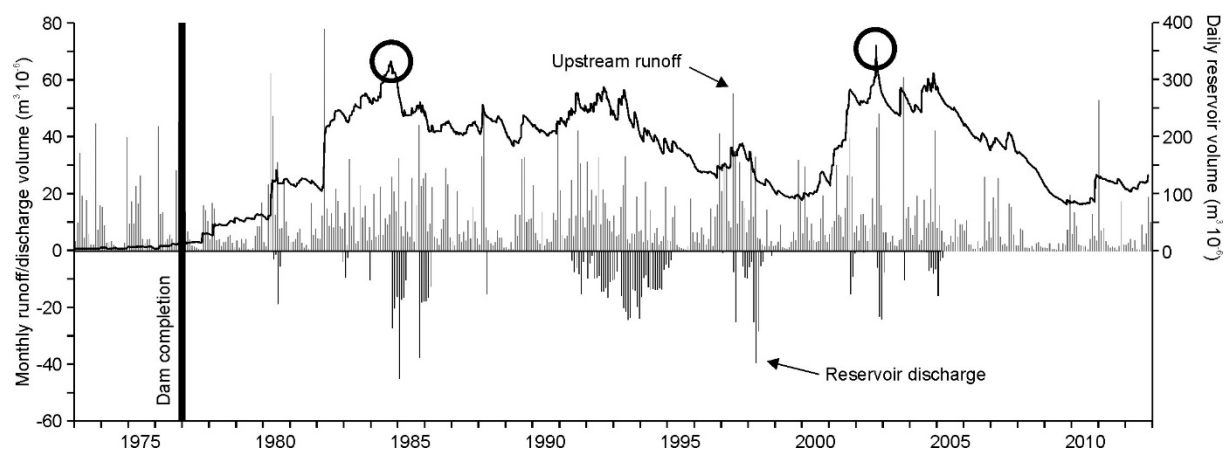
Fig. 2. Monthly runoff volume upstream from the dam and monthly volumes of reservoir discharge over the period 1973-2012. Upstream runoff volumes were estimated from rainfall using the GR2M model (Makhlouf and Michel, 1994). Monthly volumes of reservoir discharge over the period 1973-1988 were calculated by solving the reservoir water balance

equation (missing data). Daily reservoir volumes were illustrated to provide an idea of the hydrological magnitude of the dam relative to that of the river. Circles indicate episodes of overflow spills.

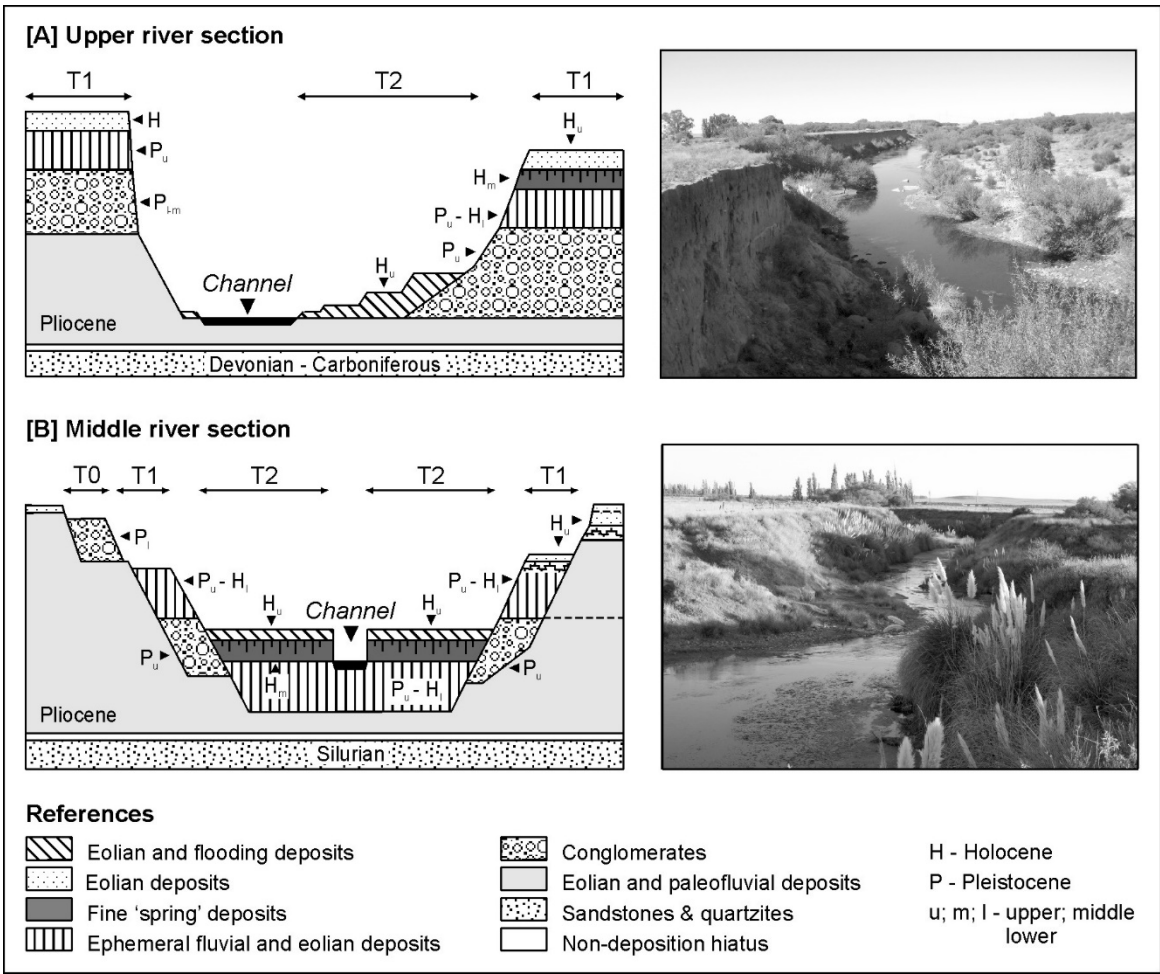
Fig. 3. Schematic cross sections of the Sauce Grande River showing typical geomorphic and

geologic characteristics within the upper and middle river sections. Geologic features were modified from Borromei (1991), Zavala and Quattrocchio (2001), and Quattrocchio et al. (2008). Not to scale.

Downstream variations in channel forms and size are apparent (Fig. 3) and conceivably linked to the attenuation of floods and flow transmission losses characteristic of dryland environments (Tooth, 2000a). In the upper section, the river channel is wide, shallow, and develops on the bottom of the incised valley. Migration of the meanders and point bar building outward led to formation of small terrace steps that have changed the original configuration of the valley bottom. In the middle river section, the valley broadens markedly, the terraces lose altitude, and the degree of confinement decreases. The river flows through a narrow, deep, and tortuous channel that constitutes a remnant of an ancient braided morphology (Borromei, 1991). Former braids were covered by aeolian deposits, and the present floodplain constitutes an abandoned portion of the original braided channel.

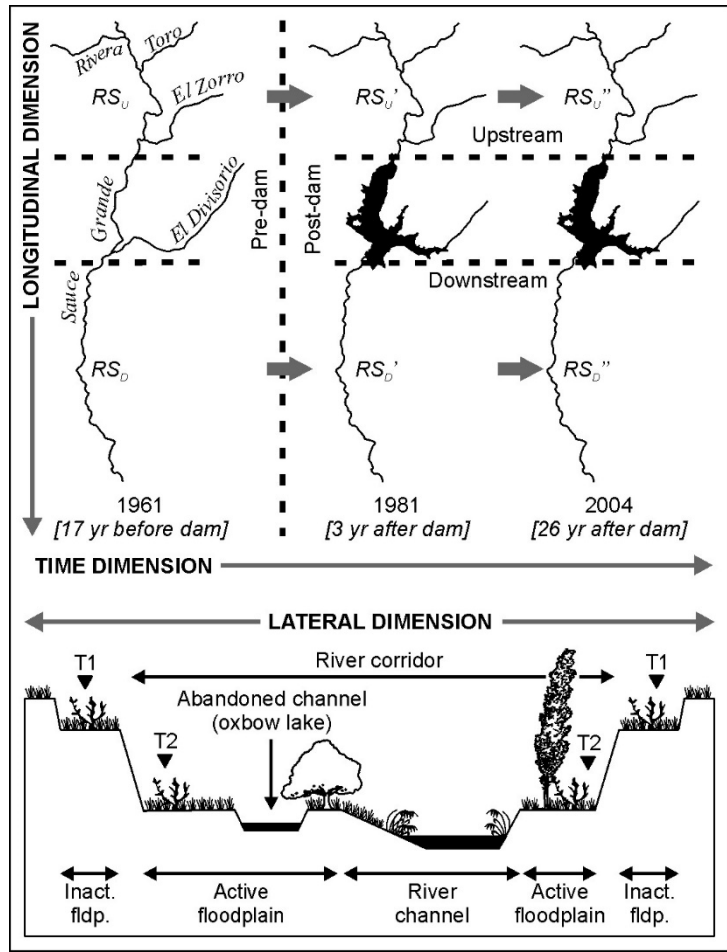
Fig. 4. Spatial and temporal scales used in geomorphic and vegetation analysis. Quantification of change within the regulated river segment (RS<sub>D</sub>) is performed with time (RS<sub>D</sub> → RS<sub>D</sub>'') and with respect to the unregulated river segment upstream (RS<sub>U</sub>). Upstream and downstream river segments were delineated by the extent of the river corridor in each time step.

This paper quantifies post-dam geomorphic and vegetation changes across multiple scales (Fig. 4). Changes with time were inspected using a chronological sequence of historical aerial photographs (1961, 1981) and high-resolution imagery (Ikonos, 2004) defining two comparative periods. The first period (1961-1981) spans a pre-disturbance phase, characterized by unregulated flow conditions, and a phase of early disturbance linked to dam completion in 1978 and initial filling of the reservoir (Fig. 2). The second period (1981-2004) spans the post-disturbance phase where the dam controls the magnitude, frequency, duration, and variability of downstream flows. Changes from unregulated to regulated river conditions for a given time step were inspected by contrasting two river segments located above and below the dam (~26- and 41-km length, respectively). In addition, field-based descriptions of

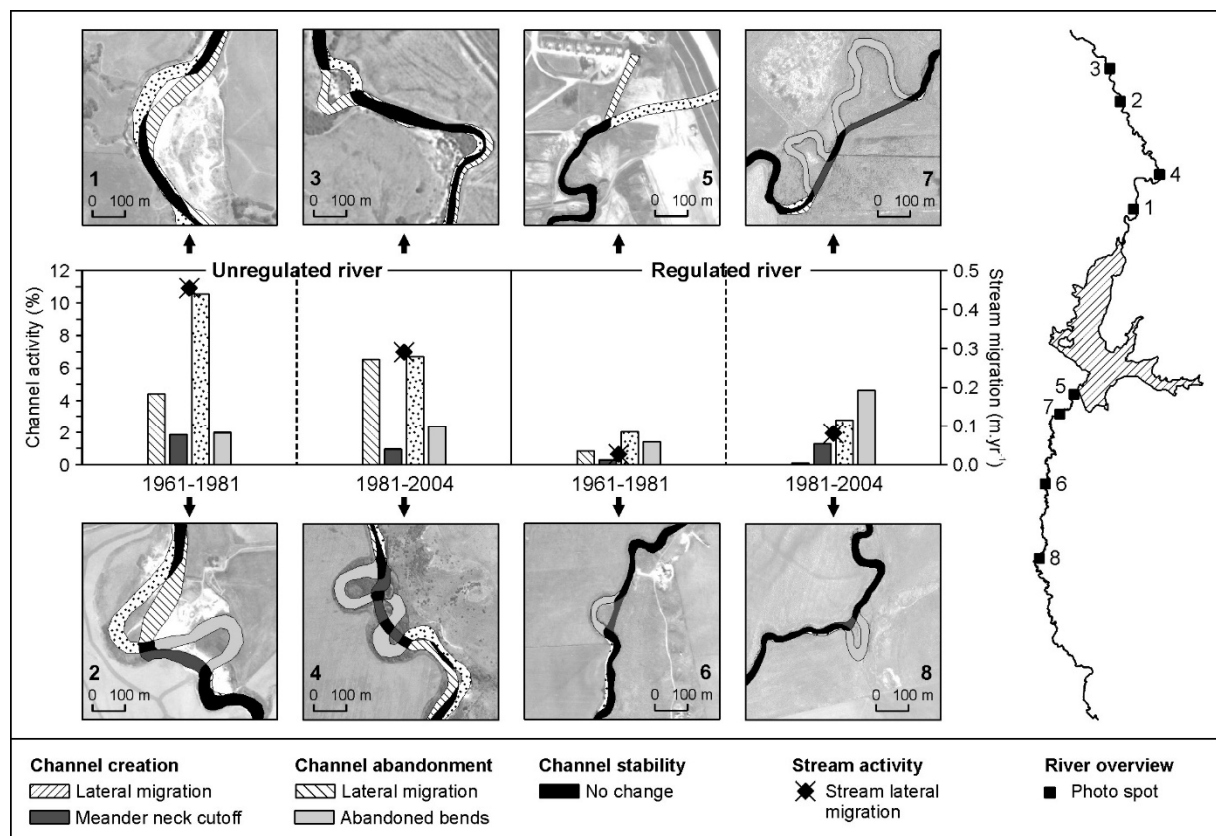
Fig. 5. Channel and stream activity within the unregulated and regulated river segments by

comparative period. Boxes provide an overview of major planform changes above and below the dam per comparative period. The scheme on the right shows the relative situation of major planform changes within each river segment.

The unregulated river exhibited marked channel activity (Table 1; Fig. 5). Although new channel surfaces were created by meander migration (10.6%) and cutoff (2.1%), the period 1961-1981 was characterized by abandonment of channel surfaces owing to meander translation (15.1%; Fig. 5, Ex. 1) and abandonment of meander bends (3.1%; Fig. 5, Ex. 2). Channel activity during the period 1981-2004 was clearly dominated by meander extension and translation. High percentages of channel abandonment (19.8%) indicate a tendency to channel straightening. Yet increased bend amplitude in some river sections was notable (Fig. 5, Ex. 3), and three major cutoffs in the middle-lower river segment (Fig. 5, Ex. 4) give evidence of the geomorphic effectiveness of floods during the second comparative period.

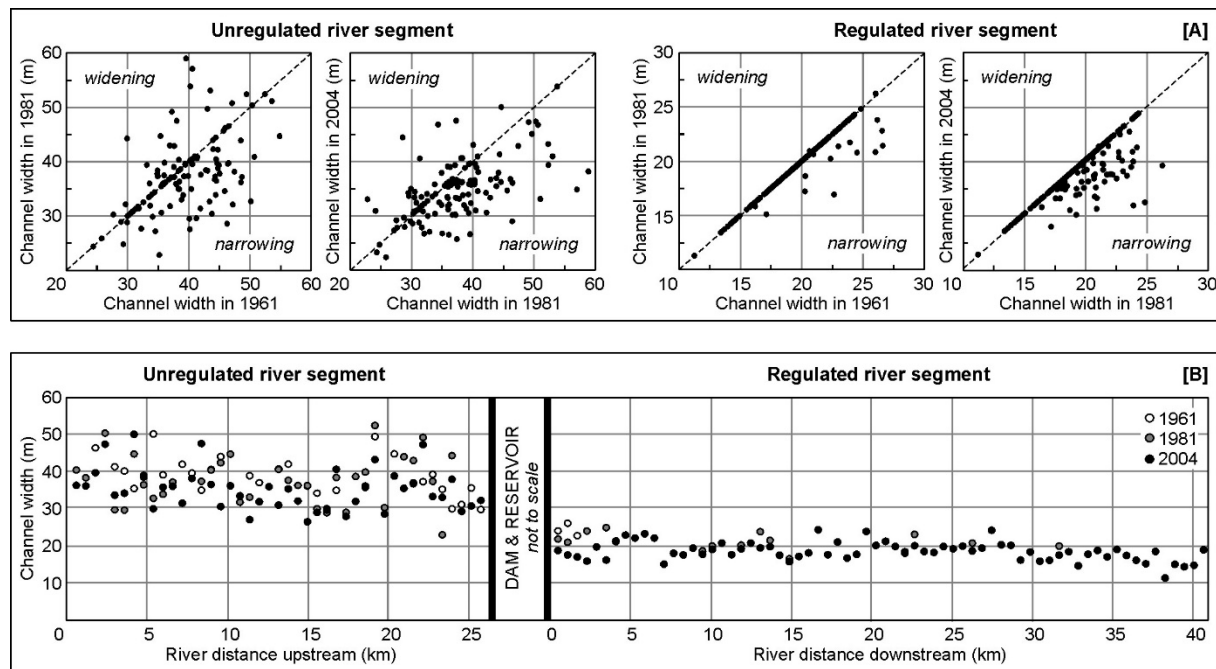
Fig. 6. [A] Scatterplots comparing the river channel width between consecutive time steps, and [B] river channel width as a function of time and distance downstream. Channel width was calculated as a function of channel area divided by 200-m length along each river segment. The hashed central line in [A] indicates a situation of no change between consecutive time steps. Data in [B] were reduced to improve readability (1 point every 600 m of channel length). The error margin for an exceedance probability of 10% is 4.8 m.

Upstream from the dam, coupled channel widening and narrowing occurred during both comparative periods with a tendency to narrowing during the second comparative period (Fig. 6). Width changes occurred most likely in river sections exhibiting active lateral migration. Thus, many channel sections narrowed owing to lateral accretion and outward migration of

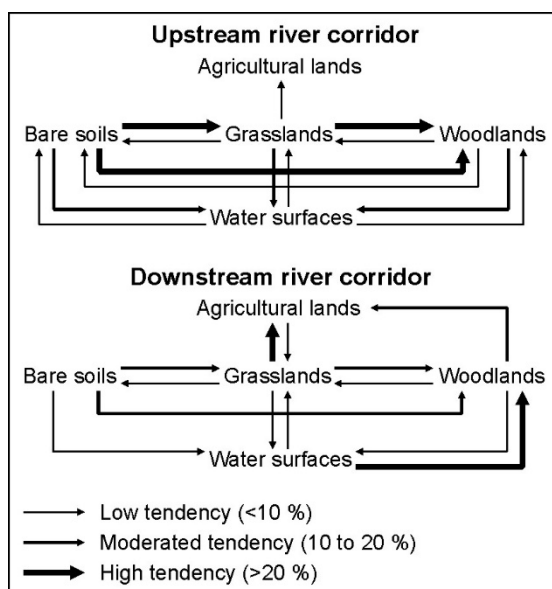
Fig. 7. Trends in vegetation dynamics within the river corridors upstream and downstream from the Paso de las Piedras Dam. Trends were calculated from transitional diagrams of landscape units by comparative period.

Second, the river corridors upstream and downstream from the dam revealed contrasting trends in vegetation dynamics (Fig. 7). Other than the expansion of agricultural lands over grasslands (583% between 1961 and 2004; Table 2), the most important transitions downstream occurred from water surfaces to woodlands (38%). This suggests a tendency for woody vegetation establishment within the river channel, near to the water surface. A moderated tendency for woody vegetation growth over former bare banks (18%) and

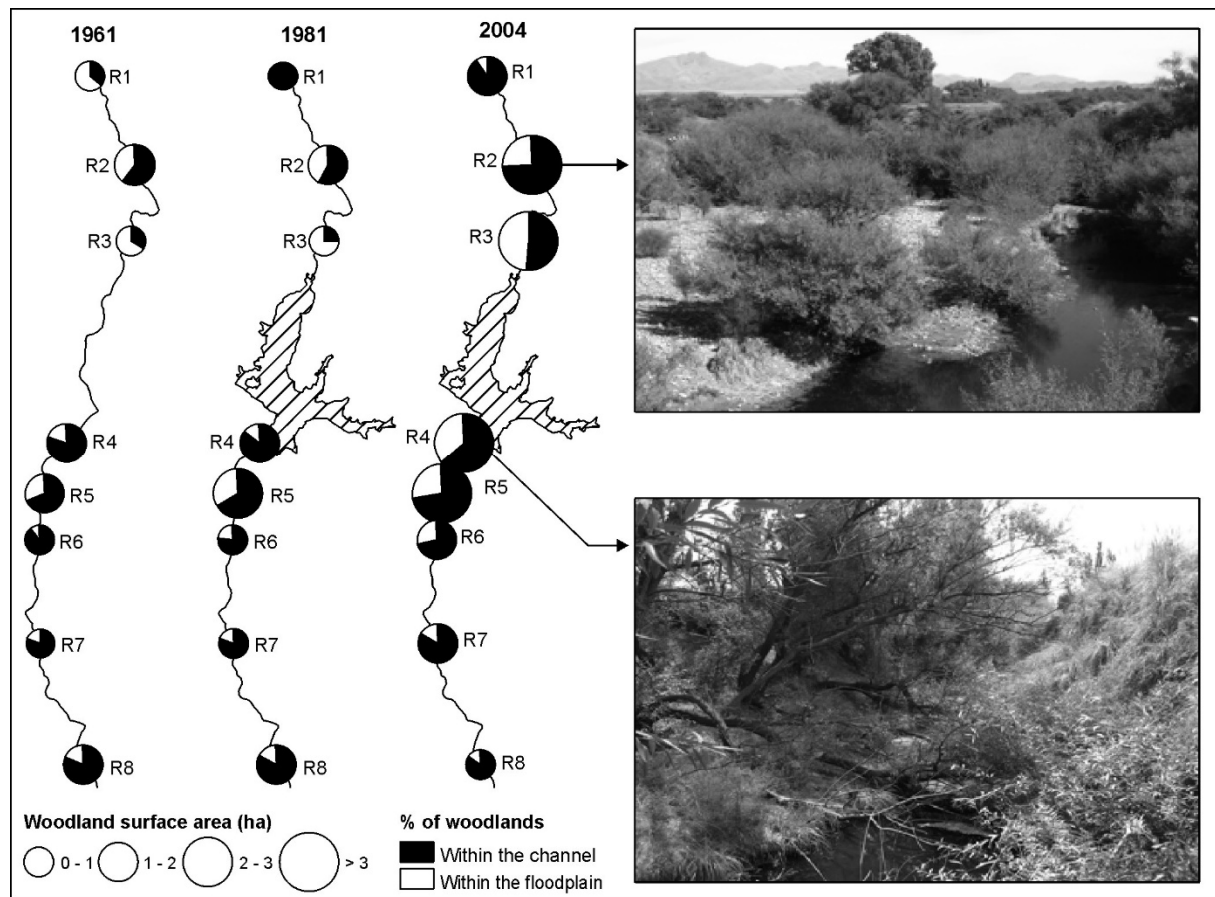
Fig. 8. Surface area occupied by woodlands by river reach (R) and time step. Pie charts differentiate percentages of woody vegetation developing within the river channel and the floodplain. Photos provide an example of vegetation encroachment within the channel upstream and downstream from the dam.

Third, woody vegetation establishment within the river corridor downstream from the dam was discontinuous, decreased in the downstream direction, and constrained almost exclusively to the river channel. Analysis at the scale of the reference reaches (Fig. 8) revealed three distinct patterns of woody vegetation establishment with distance from dam closure: (i) immediately downstream from the dam and over ~10 river km, woody vegetation develops within the channel and adjacent to the water surface forming extensive and continuous alignments (e.g., R4 and R5); (ii) downstream thereafter, woody vegetation develops in a narrow and discontinuous strip along the stream over ~20 river km (e.g., R6 and R7); (iii) downstream from river km 30, channel vegetation is dominated by grasslands and alternating alignments of young willows developing near the water surface (e.g., R8).

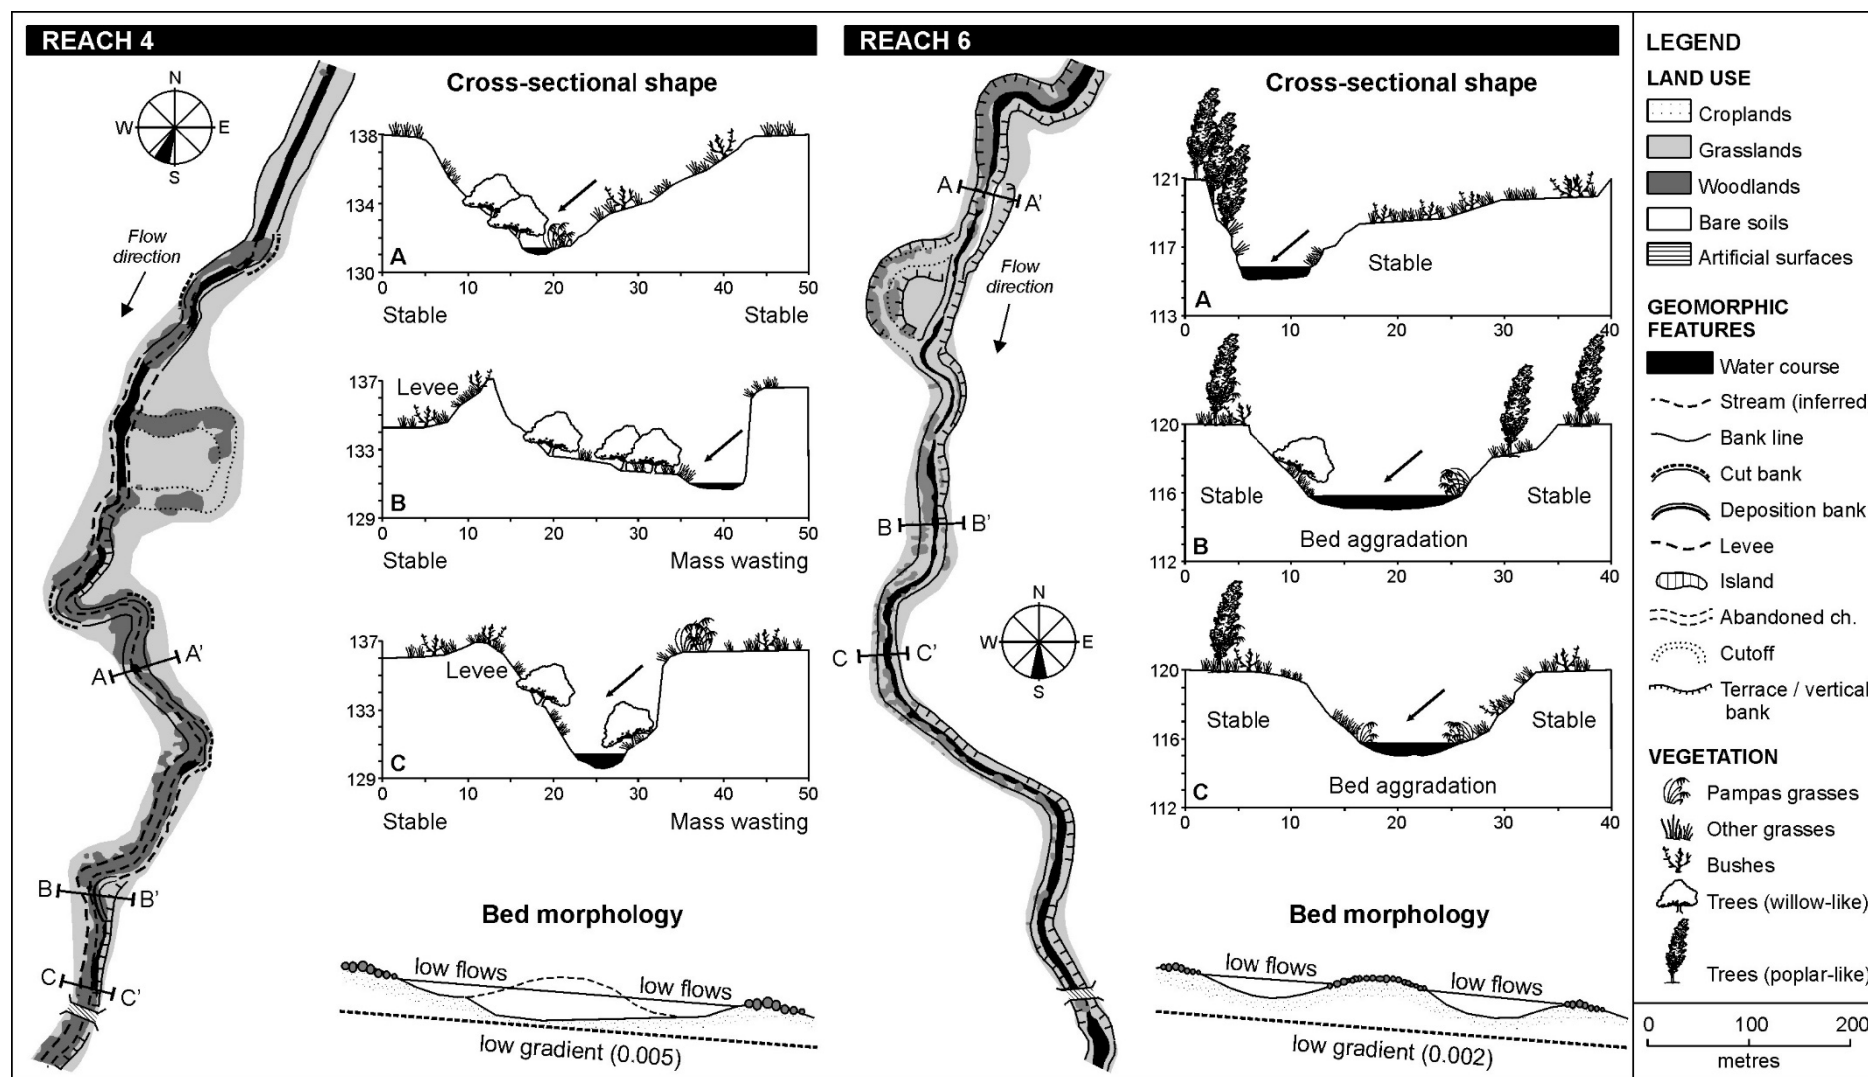
Fig. 10. Geomorphic features, land cover types, and representative cross sections for two reference reaches located downstream from the Paso de las Piedras Dam. The locations of the reference reaches along the regulated river segment downstream are shown in Fig.1.

The river channel below the dam is narrow and deep ( $7 < w:d < 10$ ), and the floodplain is much reduced (Fig. 10). Mean channel width is 21 m ( $\pm 6$  m), and mean floodplain width is 53 m ( $\pm 30$  m). Except for R5 where meanders are very tortuous ( $S = 2.8$ ), sinuosity increases in the downstream direction from 1.3 to 2.2. Bed material is composed of small gravel in riffles and of silt/clay in pools; banks exhibit cohesive layers of fine ‘spring’ and ephemeral fluvial-aeolian deposits. Bank profiles display stable conditions for most river reaches, except for R4 where mass wasting occurs in vertical banks with little vegetation cover. Immediately below the dam, any evidence of channel activity is related to human intervention. For example, artificial bed deepening in R4 facilitates evacuation of dam outlets and spills, and artificial levees (built by dredging floodplain material) prevent bank overflowing. Outside the vicinity of the impoundment, bed deposition of very fine materials (silt/clay and organic matter) leads to localized reduction of the channel depth (e.g., R6; Fig. 10).

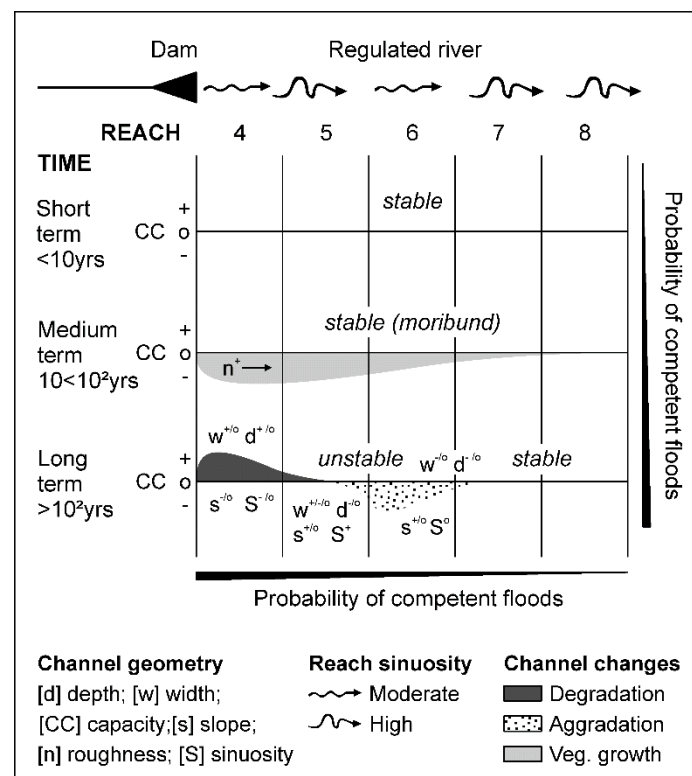
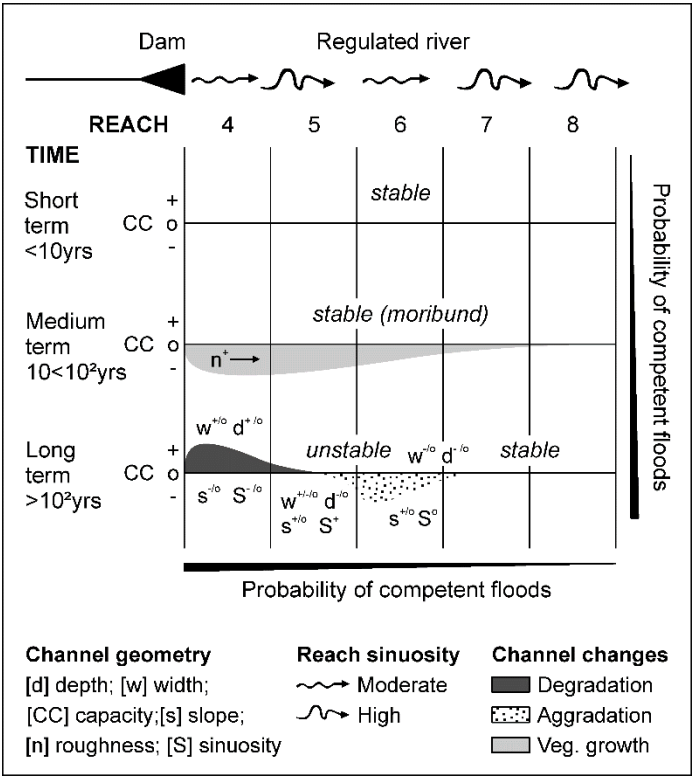
Fig. 11. Adjustment of the channel morphology to extreme flow regulation below water-storage reservoirs in drylands. The model of adjustment (modified from Petts, 1979) considers

the potential for change relative to the frequency and intensity of competent floods with time and distance from dam closure. The direction of change is indicated by [o] no significant change, [+] increase, and [-] decrease.

The unregulated Sauce Grande is in a transient, unstable state (sensu Tooth and Nanson, 2000) where complete adjustment of form to process is inhibited until a geomorphologically significant flood event occurs. After impoundment by a large surface-area, water-storage reservoir such as Paso de las Piedras, competent floods downstream are unlikely. The channel morphology will not change, and downstream flows will simply accommodate within the existing channel form. As the regulated Sauce Grande receives no major tributaries, the probability of competent floods decreases with distance downstream and so stability will prevail throughout all reaches (Fig. 11).

Yet a geomorphically significant flood is likely to occur with time (Fig. 11). If so, degradation may occur immediately below the dam (reach 4) increasing channel depth and width.
